City of Goshen

Pavement Management Plan

November 2020

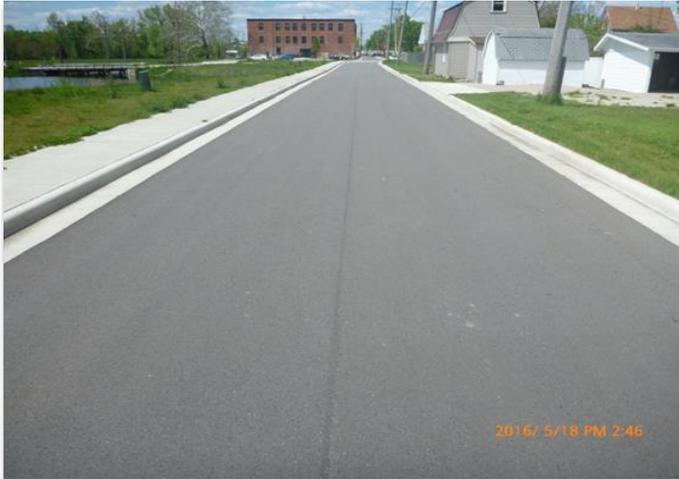
PASER Rating 9

There are no visible distresses in PASER ratings 9 and 10 because they are new constructions or recent overlays.

Pictured is River Race Drive between Madison Street and Monroe Street shows no signs of wear.

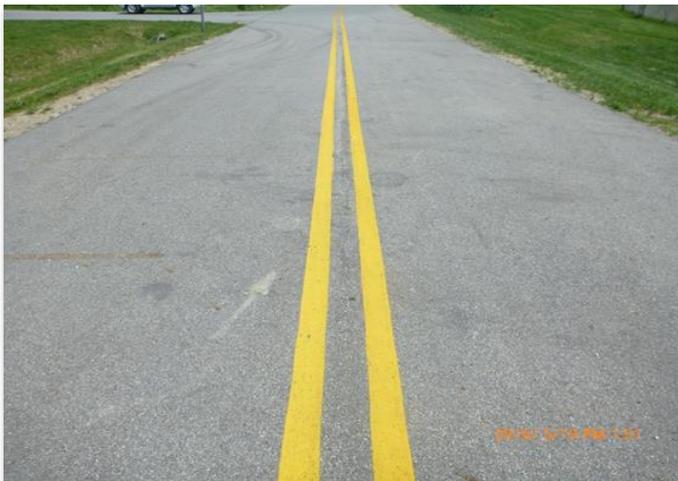
PASER Rating 8

Roadways with a PASER rating 8 have no longitudinal cracks, except for reflection of pavement joints. Occasional transverse cracks spaced 40 feet or more apart. All cracks are sealed or tight (open less than 1/4").

Pictured is Martin Avenue from the Meijer Access Road to Corporate limits. This roadway has small occasional cracks, and requires very little maintenance.

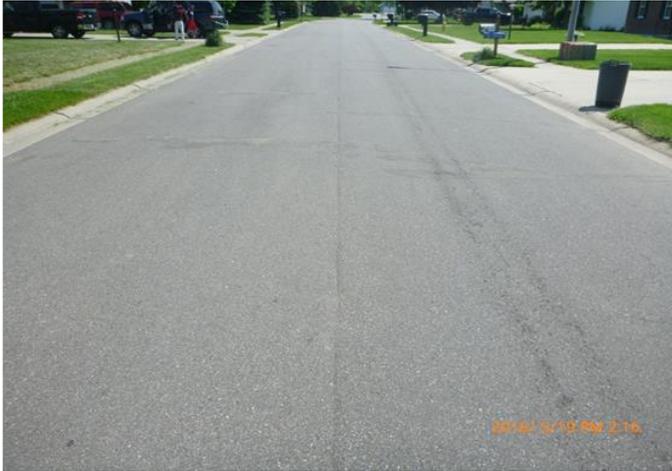
PASER Rating 7

PASER rating 7 pavement can include very slight or no raveling and shows some surface wear. Longitudinal cracks from reflection or paving joints can be up to 1/4" wide and transverse cracks can be up to 1/4" wide and spaced between 10' and 40' apart. There is little or slight crack raveling, no patching, or very few patches in excellent condition.

Pictured is Wheatland Drive from Barley Lane to Oatfield Lane. This roadway has some longitudinal cracks. There are also transverse cracks 10'-40' apart. Most of the cracks are not open due to being crack sealed in 2015.

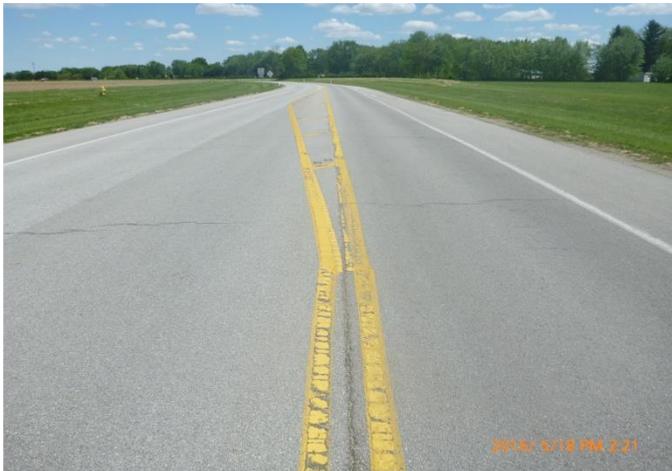
PASER Rating 6

Roadways with a PASER rating of 6 are starting to show signs of traffic wear and/or raveling. There are open longitudinal cracks with a width between 1/4"-1/2". Transverse cracks are open with a width between 1/4"-1/2" with some being less than 10' apart. The first signs of block cracking can appear, slight to moderate flushing or polishing, and it may have occasional patches in good condition.

Pictured is Waterford Mills Parkway between Regent Street and Edison Drive. This roadway has transverse cracks that are open between 1/4" and 1/2" and are less than 10 feet apart. Some longitudinal cracking along the corridor.

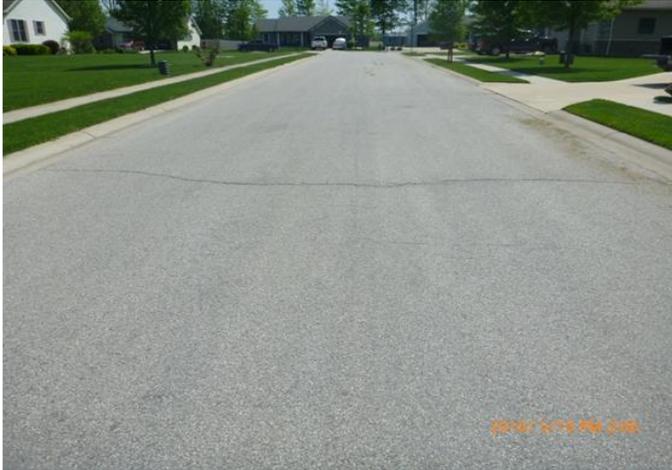
PASER Rating 5

Roadways with a PASER rating of 5 have moderate to severe raveling, longitudinal and transverse cracks open 1/2" or more and secondary cracks. Block cracking on up to 50% of the pavement surface, extensive to severe polishing, and some patching or wedging in good condition.

Pictured is Mountain Ash Lane between Redpire Boulevard and Tulip Boulevard. This roadway has transverse cracks that are greater than 1/2" wide.

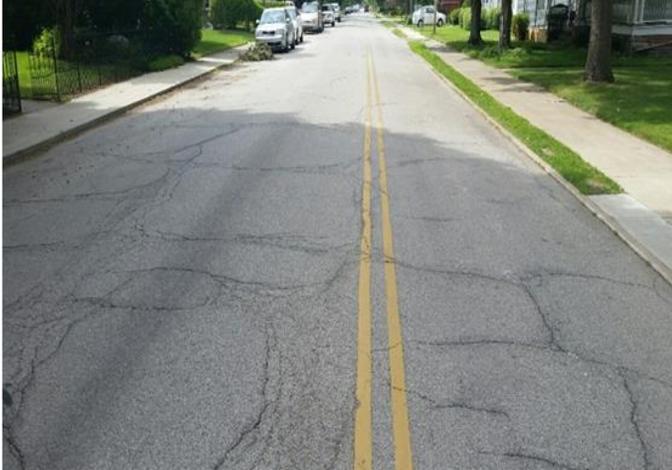
PASER Rating 4

PASER rating 4 roadways have severe surface raveling, multiple longitudinal and transverse cracks with slight raveling, block cracking over 50% of the surface, patching in fair condition, and rutting of less than 1/2".

Pictured is Sixth Street between Lincoln Avenue and Washington Street. This roadway has longitudinal cracks in the wheel path and the block cracking.

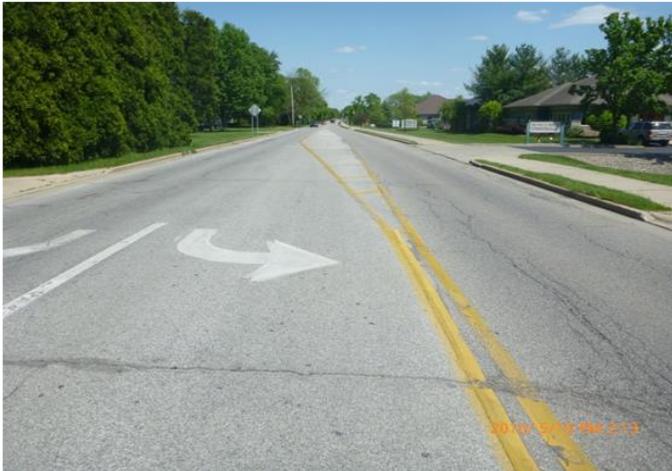
PASER Rating 3

Roadways with PASER rating 3 may have closely spaced longitudinal and transverse cracks, severe block cracking, alligator cracking on less than 25% of the surface, patches in fair to poor condition, occasional potholes, and rutting between 1/2" and 2".

Pictured is Lincoln Avenue between Greene Road and Silverwood Lane. This roadway has longitudinal and transverse cracks that are showing erosion, and there is also rutting in the wheelpath.

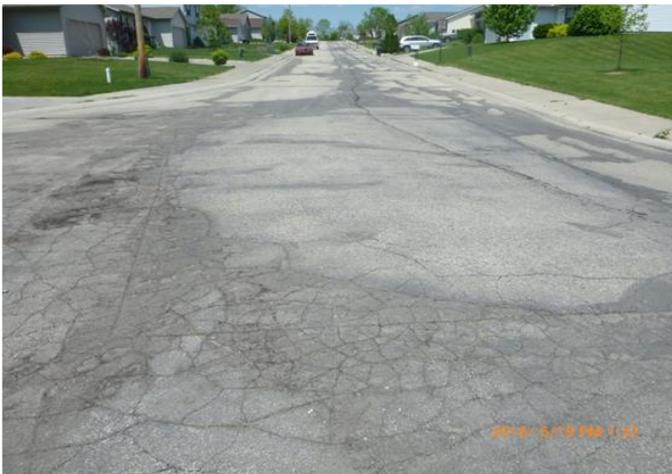
PASER Rating 2

A PASER rating 2 road has cracking over 25% of the surface, rutting greater than 2", patches in poor condition, and potholes.

Pictured is VanGuilst Drive between Alfalfa Street and Michigan Street. This roadway has alligator cracking over 25% of the surface, and patches that are in poor condition.

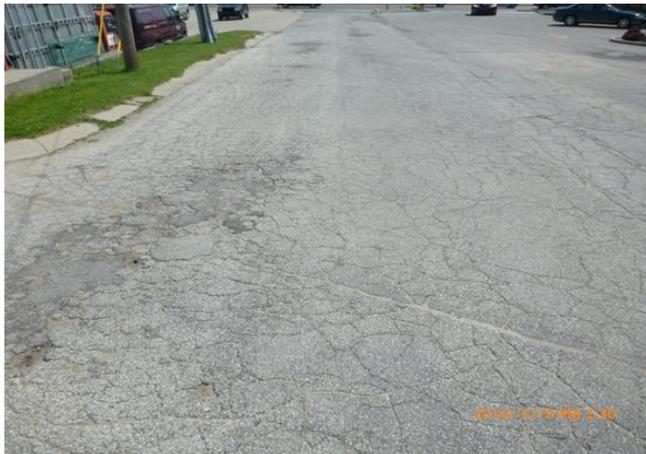
PASER Rating 1

PASER rating 1 roadways have severe distress with a loss of surface integrity.

Pictured is Westfield Drive between Pike Street and Wilkinson Street. This roadway has extensive alligator cracking and multiple patches that are in poor condition making it a PASER rating 1.

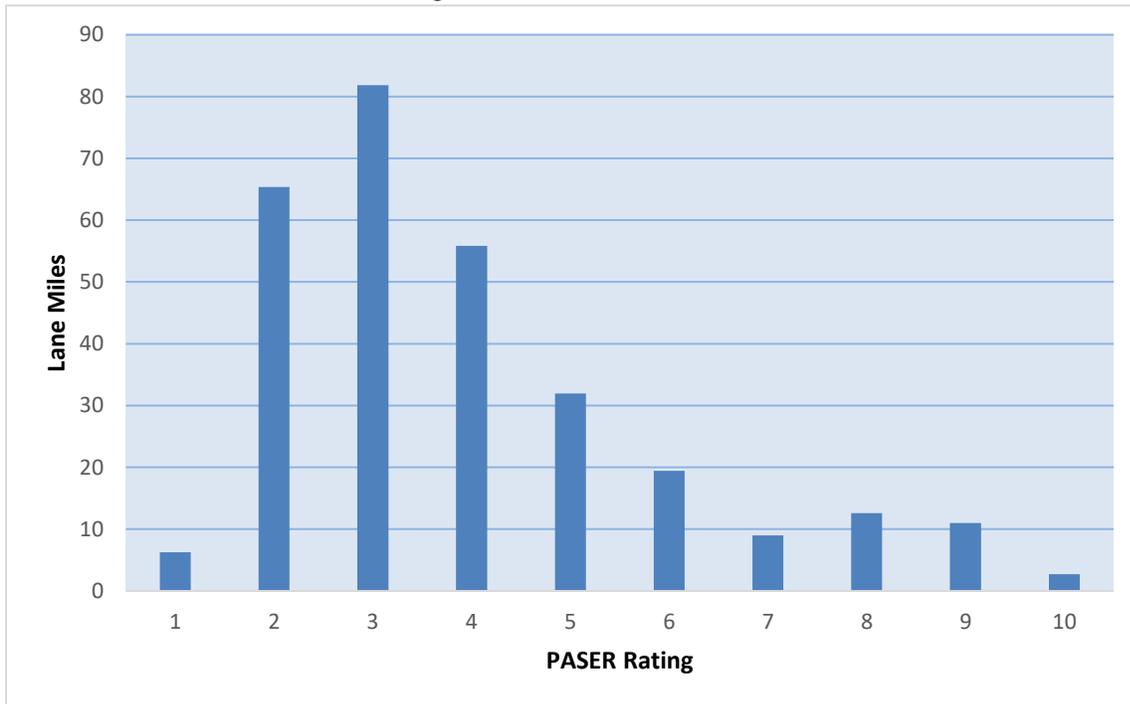
Results of the 2020 PASER ratings are shown below in chart form.
