City of Goshen

Pavement Management Plan

November 2021

Report Overview

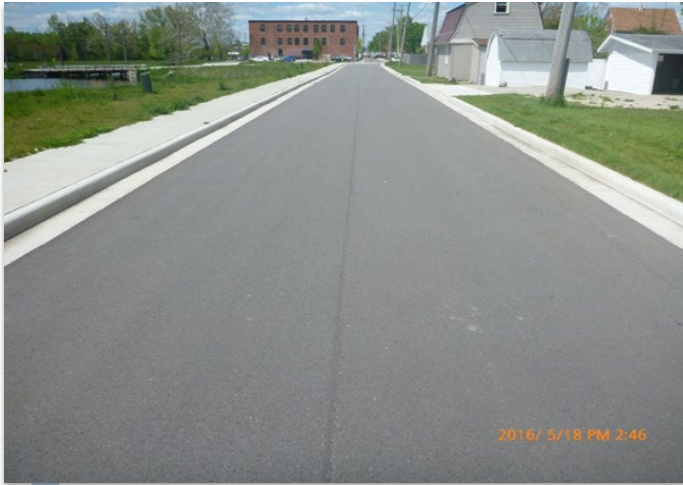
PASER Rating 9

There are no visible distresses in PASER ratings 9 and 10 because they are new constructions or recent overlays.

Pictured is River Race Drive between Madison Street and Monroe Street shows no signs of wear.

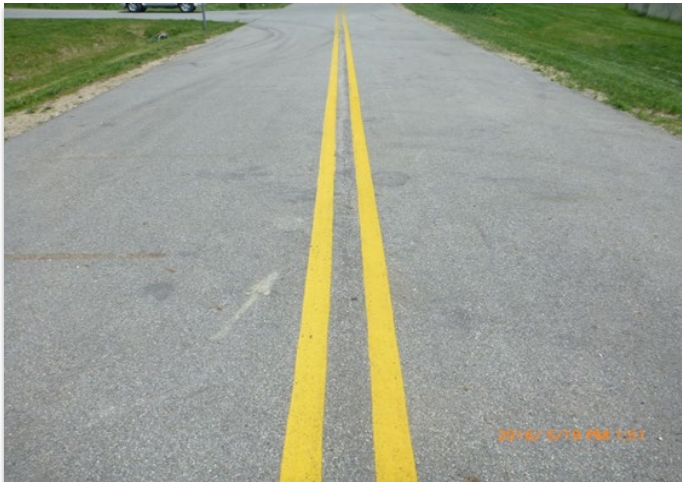
PASER Rating 8

Roadways with a PASER rating 8 have no longitudinal cracks, except for reflection of pavement joints. Occasional transverse cracks spaced 40 feet or more apart. All cracks are sealed or tight (open less than 1/4").

Pictured is Martin Avenue from the Meijer Access Road to Corporate limits. This roadway has small occasional cracks, and requires very little maintenance.

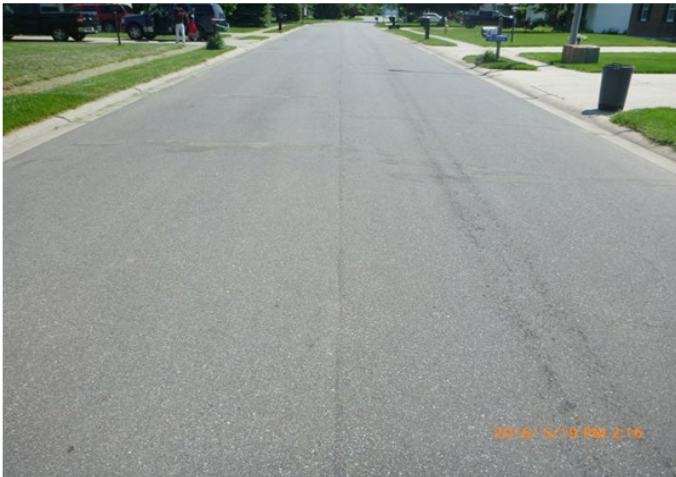
PASER Rating 7

PASER rating 7 pavement can include very slight or no raveling and shows some surface wear. Longitudinal cracks from reflection or paving joints can be up to 1/4" wide and transverse cracks can be up to 1/4" wide and spaced between 10' and 40' apart. There is little or slight crack raveling, no patching, or very few patches in excellent condition.

Pictured is Wheatland Drive from Barley Lane to Oatfield Lane. This roadway has some longitudinal cracks. There are also transverse cracks 10'-40' apart. Most of the cracks are not open due to being crack sealed in 2015.

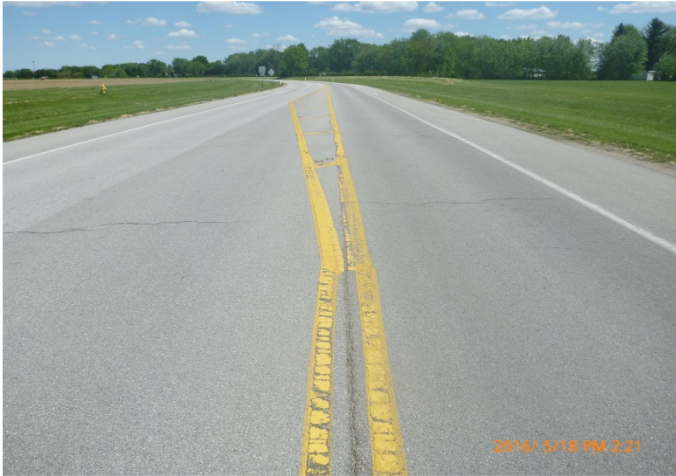
PASER Rating 6

Roadways with a PASER rating of 6 are starting to show signs of traffic wear and/or raveling. There are open longitudinal cracks with a width between 1/4"-1/2". Transverse cracks are open with a width between 1/4"-1/2" with some being less than 10' apart. The first signs of block cracking can appear, slight to moderate flushing or polishing, and it may have occasional patches in good condition.

Pictured is Waterford Mills Parkway between Regent Street and Edison Drive. This roadway has transverse cracks that are open between 1/4" and 1/2" and are less than 10 feet apart. Some longitudinal cracking along the corridor.

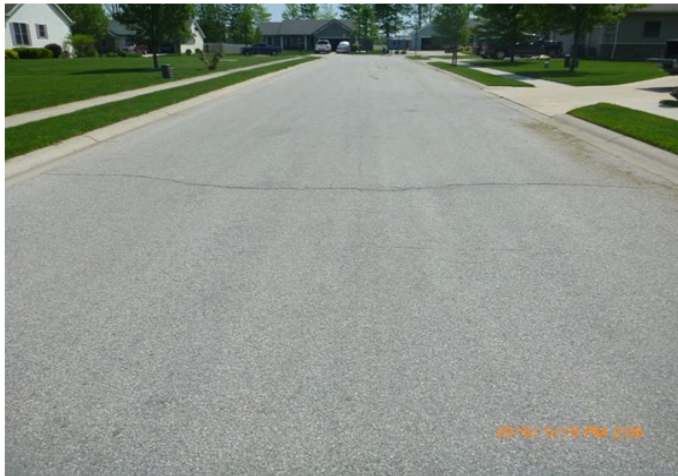
PASER Rating 5

Roadways with a PASER rating of 5 have moderate to severe raveling, longitudinal and transverse cracks open 1/2" or more and secondary cracks. Block cracking on up to 50% of the pavement surface, extensive to severe polishing, and some patching or wedging in good condition.

Pictured is Mountain Ash Lane between Redspire Boulevard and Tulip Boulevard. This roadway has transverse cracks that are greater than 1/2" wide.

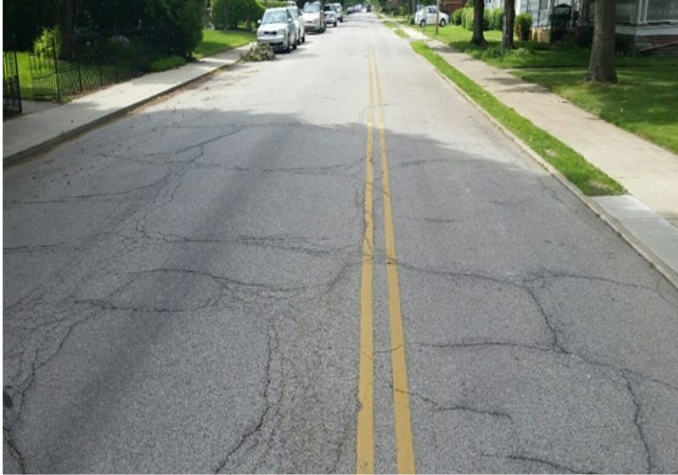
PASER Rating 4

PASER rating 4 roadways have severe surface raveling, multiple longitudinal and transverse cracks with slight raveling, block cracking over 50% of the surface, patching in fair condition, and rutting of less than 1/2".

Pictured is Sixth Street between Lincoln Avenue and Washington Street. This roadway has longitudinal cracks in the wheel path and the block cracking.

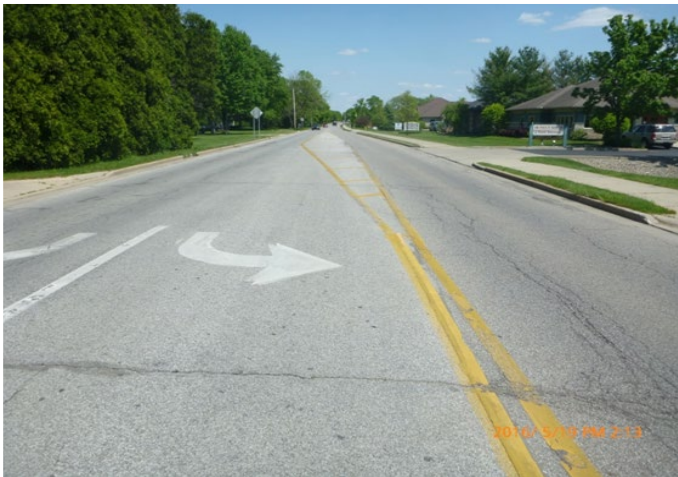
PASER Rating 3

Roadways with PASER rating 3 may have closely spaced longitudinal and transverse cracks, severe block cracking, alligator cracking on less than 25% of the surface, patches in fair to poor condition, occasional potholes, and rutting between 1/2" and 2".

Pictured is Lincoln Avenue between Greene Road and Silverwood Lane. This roadway has longitudinal and transverse cracks that are showing erosion, and there is also rutting in the wheel path.

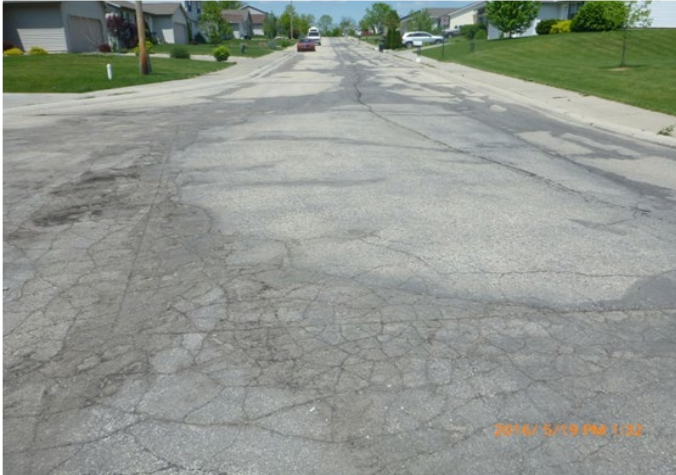
PASER Rating 2

A PASER rating 2 road has cracking over 25% of the surface, rutting greater than 2", patches in poor condition, and potholes.

Pictured is VanGuilst Drive between Alfalfa Street and Michigan Street. This roadway has alligator cracking over 25% of the surface, and patches that are in poor condition.

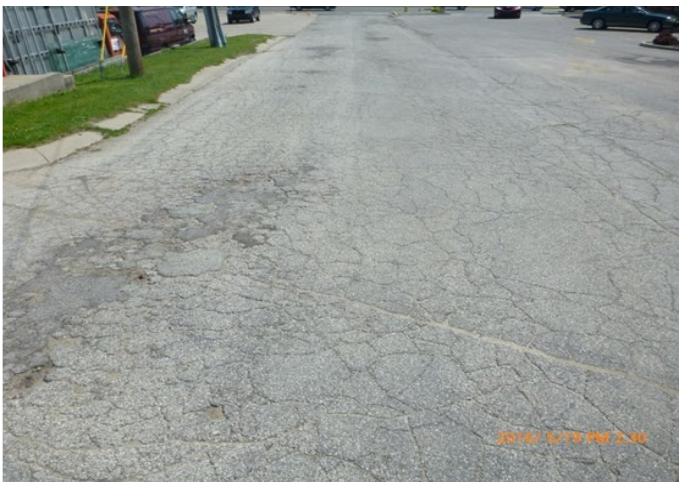
PASER Rating 1

PASER rating 1 roadways have severe distress with a loss of surface integrity.

Pictured is Westfield Drive between Pike Street and Wilkinson Street. This roadway has extensive alligator cracking and multiple patches that are in poor condition making it a PASER rating 1.
